**SUMMARY REPORT  
ON THE  
ASBESTOS ASSESSMENT SURVEY  
OF ZINC LADEN DUST  
AT THE  
BUNKER HILL  
ROASTER FLOOR BUILDING AND ROASTER BUILDING NUMBER 5  
KELLOGG, IDAHO**

Project Number: A94-013

March 7, 1994

MCS Environmental is pleased to provide you with this report for the limited Asbestos Assessment Survey of the accumulated dust and debris within the Roaster Floor Building and Roaster Building #5, Bunker Hill Complex, Kellogg, Idaho.

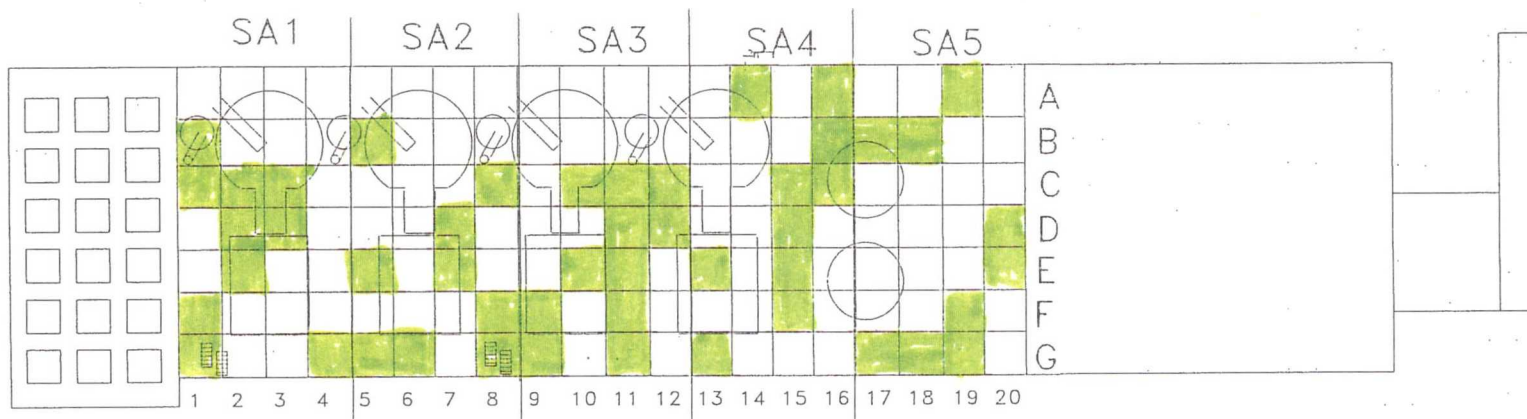
FLOOR #3

Roaster Bldg. #5

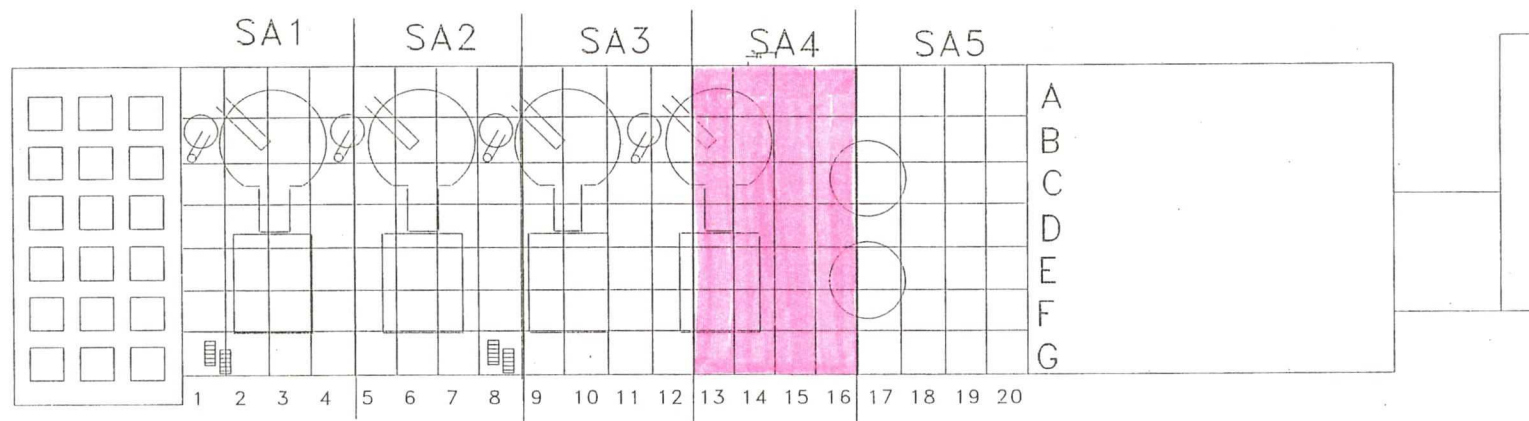
**SAMPLE AREAS WITH TRACE OR GREATER ASBESTOS DIAGRAM  
ROASTER FLOOR BUILDING & ROASTER BUILDING #5  
BUNKER HILL SUPERFUND SITE, KELLOGG, IDAHO**
